CAMBRIDGE RESERVOIR DAM
MA 00750

PHASE I INSPECTION REPORT
NATIONAL DAM INSPECTION PROGRAM

DEPARTMENT OF THE ARMY
NEW ENGLAND DIVISION, CORPS OF ENGINEERS
WALTHAM, MASS. 02154

JANUARY 1980

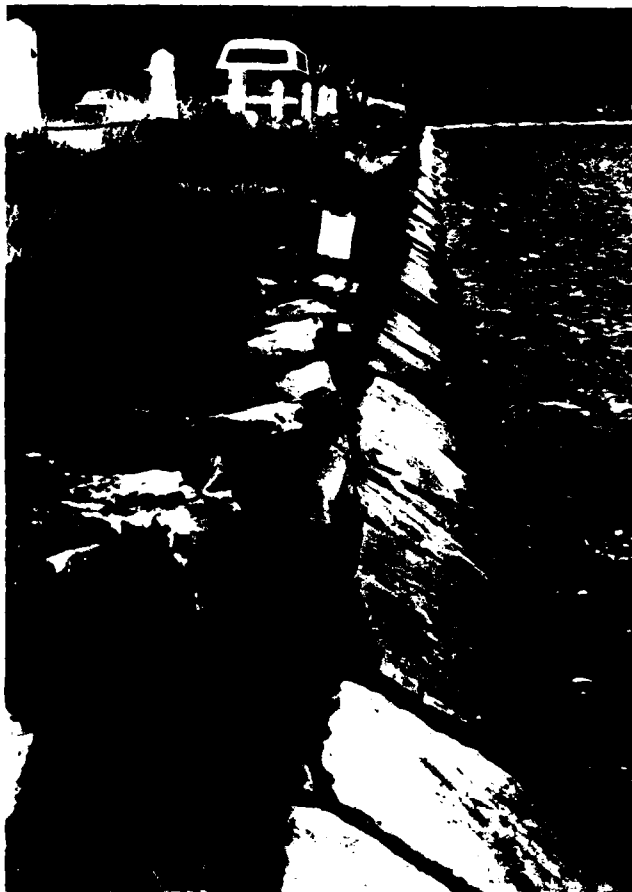
The upper riprap wall is displaced in several locations, the most deterioration being from the intake structure bridge to about 110 ft. right of the bridge, photograph 3. Photographs 2 and 4 shows undermining of the crest about 50 ft. and 90 ft. right of the bridge, respectively.

Riprap on the upper part of the upstream slope has been displaced in several locations, and sloughing of the slope near the crest has occurred in some of these locations. The downstream slope is partially covered with dumped rubble. The banks of the spillway discharge channel are eroding which, if allowed to continue, could cause instability of the dam.

PHOTO NO. 3 - Displaced riprap on upstream slope looking toward right abutment. Clipboard in photo is about 110 ft. right of intake structure.

Furthermore, the Owner should institute remedial measures including the proposed renovations of the spillway discharge channel; the proposed repair of the riprap on the upstream slope; establishment of a system for locking stoplogs in place; testing of the gates and establishment of a formal downstream warning system.

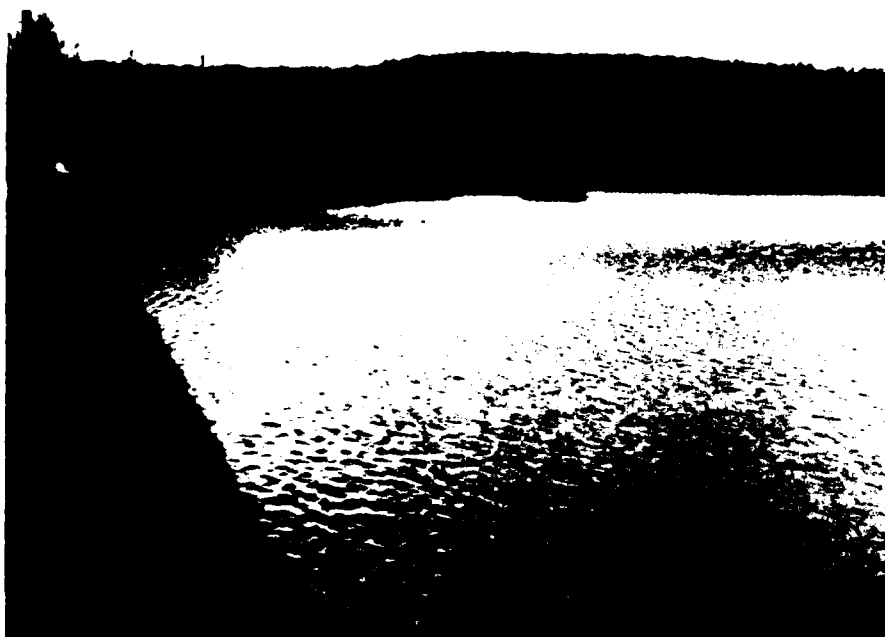
The upper 4 to 5 ft. of the upstream slope was above the reservoir level and available for inspection. A general view of the entire upstream slope is shown in photograph 8. Two types of riprap slope protection were observed, as shown in photograph 3. The upper 2.5 ft. \pm consists of a nearly vertical wall of hand placed angular boulders and cobbles; below this are hand placed cut stone pieces about 8 in. thick and ranging in size from about 1.5 ft. by 1.5 ft. to about 4 ft. by 4 ft. The cut stone pieces are sloped about 1.5 Hor.:1 Vert.

PHOTO NO. 8 - Upstream slope of Dam viewed from left
abutment area.

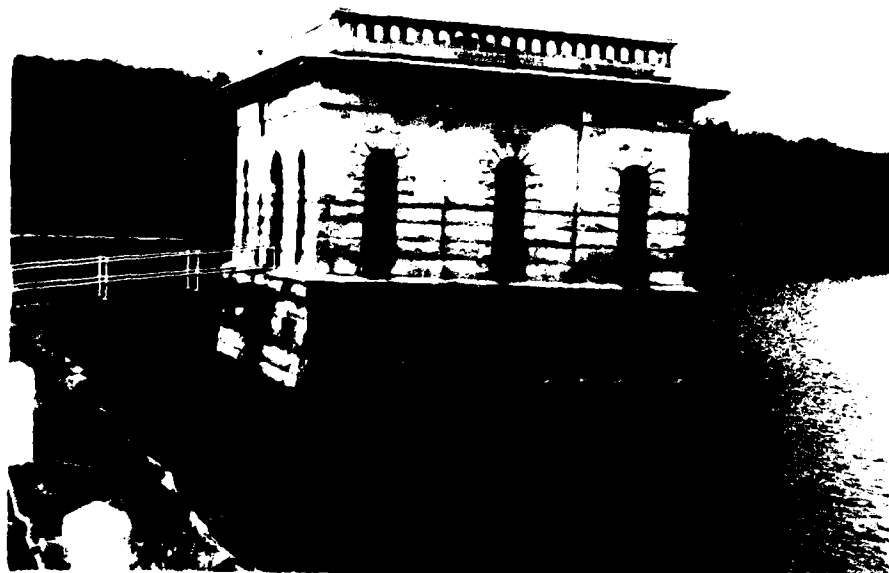
PHOTO NO. 9 - View of intake structure and service bridge. Note location of inlets to structure. Information pertaining to the location, size and inverts of the gates inside structure is not available.

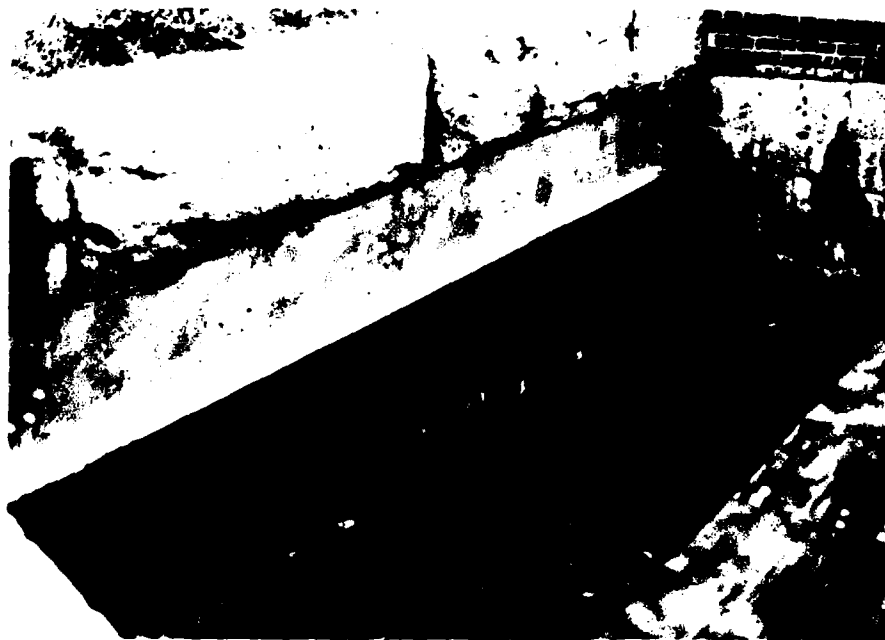
PHOTO NO. 10 - Spillway floor and opening below I beam of Winter Street Roadway Bridge. A comparison of the existing structure and plans dated 1895 indicate that the spillway has undergone some modifications during the lifetime of the Dam.

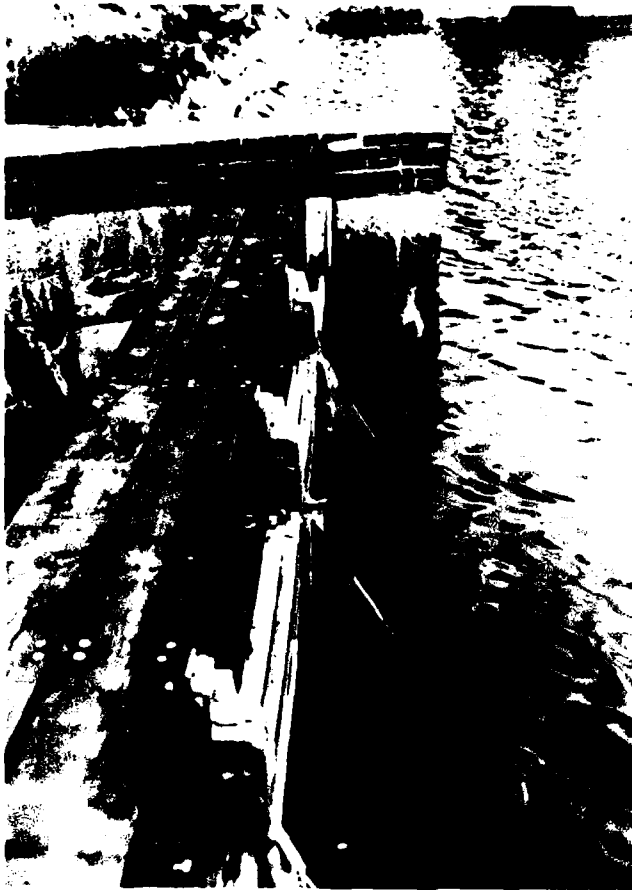
PHOTO NO. 11 - View of stop log facility for spillway. At time photo was taken there were approximately 1.9 ft. of stop logs in place. Note masonry side wall in upper portion of picture which is also visible in Photo No. 5.
